**WASTE MANAGEMENT DIVISION  
RCRA ENFORCEMENT OFFICE  
RCRA COMPLIANCE EVALUATION INSPECTION REPORT**

**Facility:** Exide Technologies

**Location:** 2700 South Indiana Street, Vernon, CA 90058

**Date of Inspection:** July 22, 2008

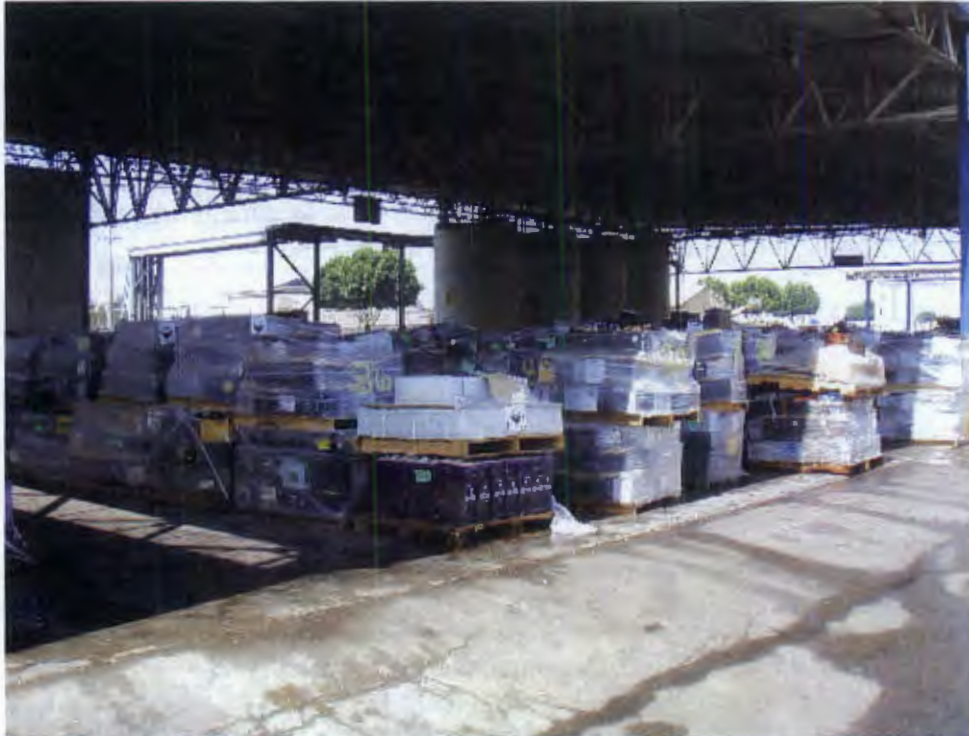
Photo 1 – SLABs in Central Container Storage Building

Location	Container Type	Waste Type	Potential Violation
Accepted Raw Material Staging Area	Approximately 225 pallets of SLABs (Photo 1)	SLABs received and accepted by Exide are stored here awaiting processing in the smelter	None
Southwest Corner of Storage Building	4 – 9,000-gal settling tanks	All storm water and dust suppression water is pumped to these tanks. Solids and liquids are pumped to the wastewater treatment unit for processing.	None
Storm Water Retention Pond (south of storage building)	2.8 million gallon pond	Empty and no longer receiving facility run-off.	None
Asphalt in front of building (Photo 2)	NA	The areas between the buildings are covered in asphalt	<b>Area of Concern –</b> The asphalt has a number of cracks that could be pathways for lead migration into the underlying soil.

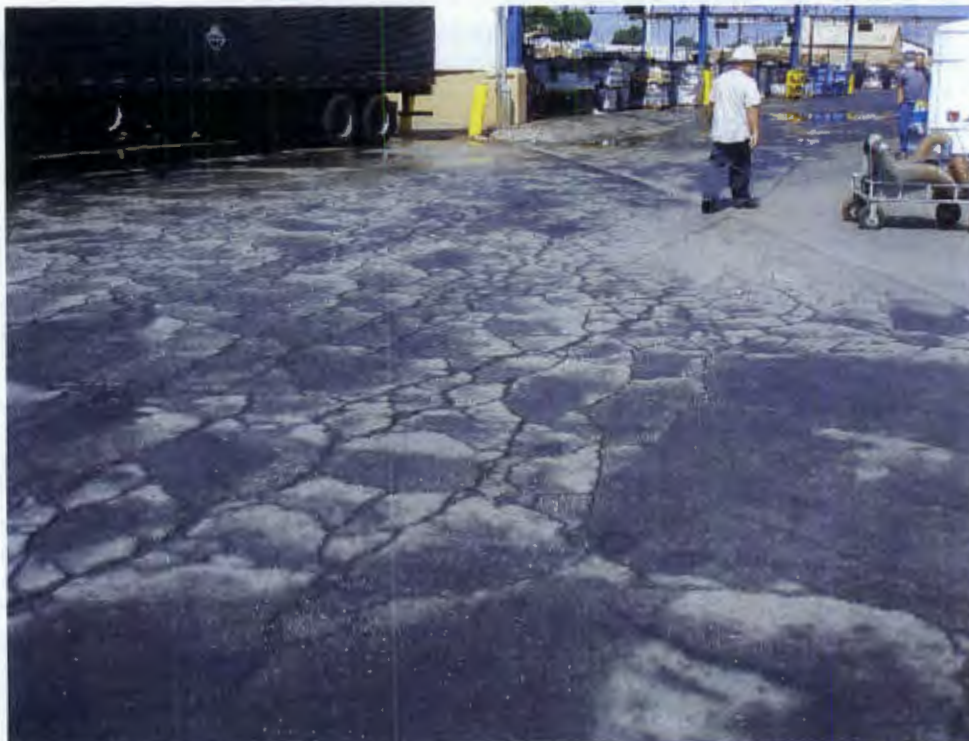
Photo 2 – Cracked asphalt paving between buildings

The areas between the buildings are covered in asphalt (Photo 2). The asphalt has a number of cracks that could be pathways for lead migration into the underlying soil. The facility conducts regular water spraying of the asphalted areas to control dust, which may contain lead; the area is then cleaned with a street sweeper. The water from dust suppression is collected in the street sweeper and transferred to the wastewater treatment unit. The facility repairs obvious asphalt cracks, but capital expenditures are focused on maintenance of the building's concrete floors because these floors are in close or direct contact with the lead and acid from the SLABs.

According to the facility representatives, the floors of the buildings are ten-inch-thick concrete. Exide conducted maintenance on the smelter floor in June 2008. They have repairs and recoating scheduled for the third quarter of 2008 on the floor of the RMPS battery cracking area. In the fourth quarter of 2008, Exide is scheduled to repair and/or replace the floors in the wastewater treatment area and the mud tank row area.

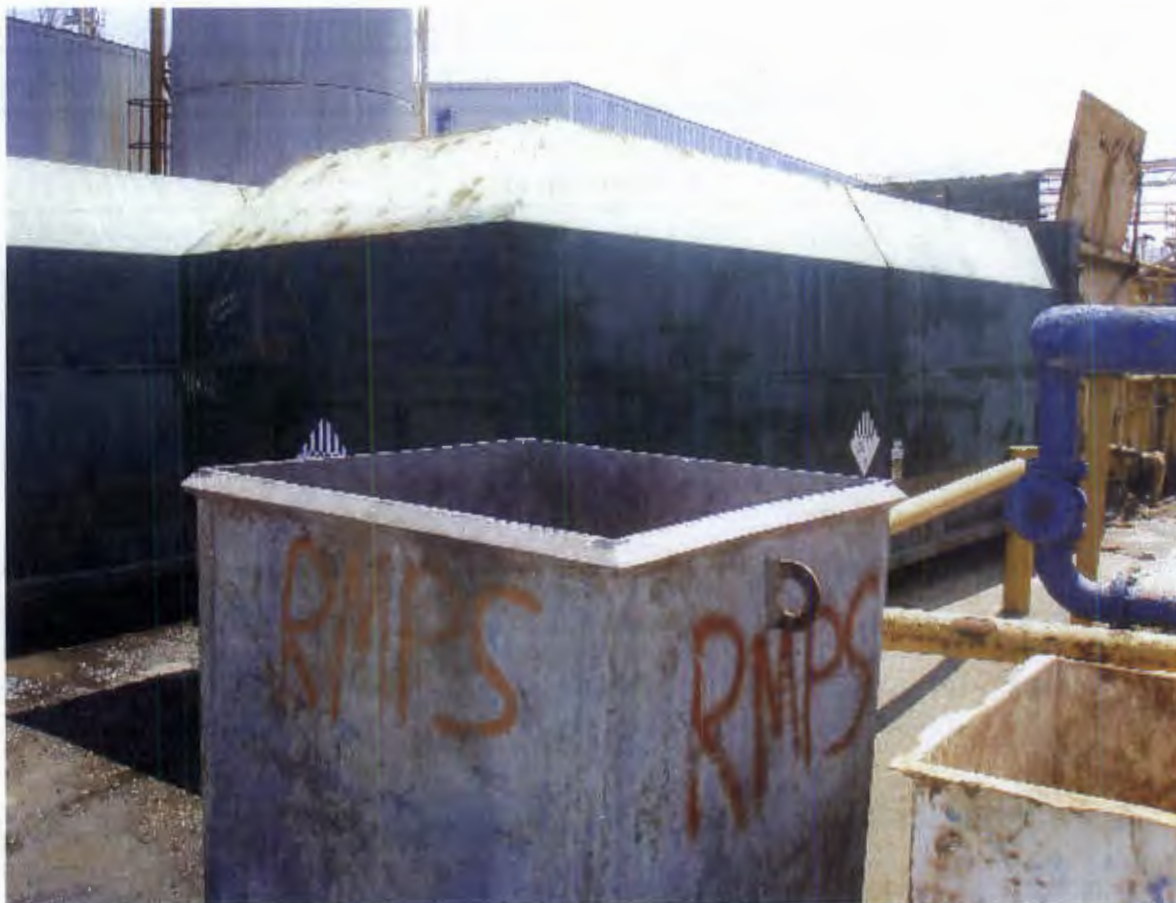
Photo 3 – Unlabeled 40-cubic-yard roll-off bin of lead debris (D008)

Location	Container Type	Waste Type	Potential Violation
Outside of southwest corner of RMPS Building	1 – 40-cubic yard roll-off bin ( <b>Photo 3</b> )	Lead debris (D008)	<b>Unlabeled container</b>
Southwest entrance to RMPS Building	NA	Battery cracking – lead, acid, and plastic separated for processing	None
Reverbatory Furnace Feed Room	NA	Lead sludge from wastewater treatment unit is stored in this room and is sent by conveyor belt through a furnace to reduce moisture to about 14% before being fed into reverberatory furnace	None

Outside the southwest corner of the RMPS Building was a 40-cubic-yard roll-off bin containing lead debris that was unlabeled. The facility representative indicated that the roll-off bin is filled and shipped off site once to twice a week and that the bin is labeled prior to transporting off site. The inspector explained to the facility representative the requirement for a hazardous waste label to be on the bin when waste accumulation begins in the bin.

Two weeks after the inspection, Exide provided a photograph documenting that the roll-off bin is now properly labeled.

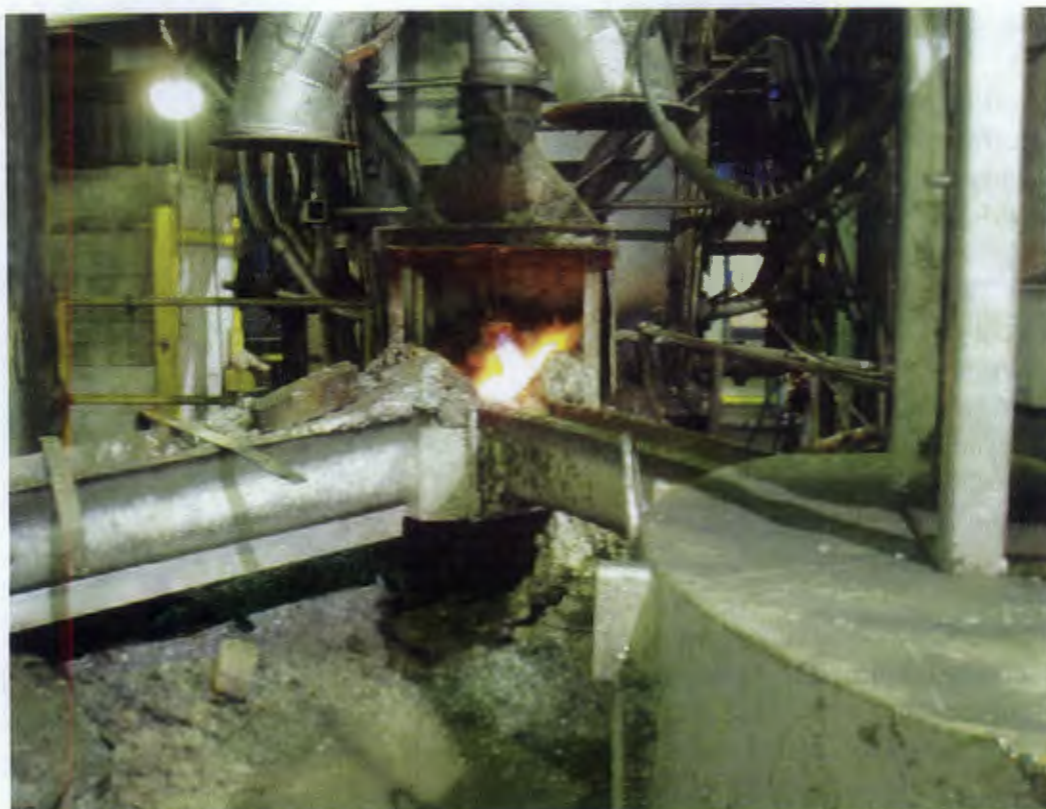
Photo 4 – Molten lead from blast furnace

Location	Container Type	Waste Type	Potential Violation
Reverberatory Furnace	NA	Lead and lead oxide is fed to reverberatory furnace to recover lead	
Blast Furnace	NA	Slag from reverberatory furnace is fed to blast furnace for lead recovery. Slag from blast furnace is fed back through furnace until enough lead has been recovered so that the slag is no longer hazardous. (Photos 4 and 5)	None
